**Task Order 2  
Enhanced Preliminary Assessment**

**BENNETT ARMY  
NATIONAL GUARD FACILITY  
DENVER, COLORADO**

January 1990

**Roy F. Weston, Inc.  
West Chester,  
Pennsylvania 19380**

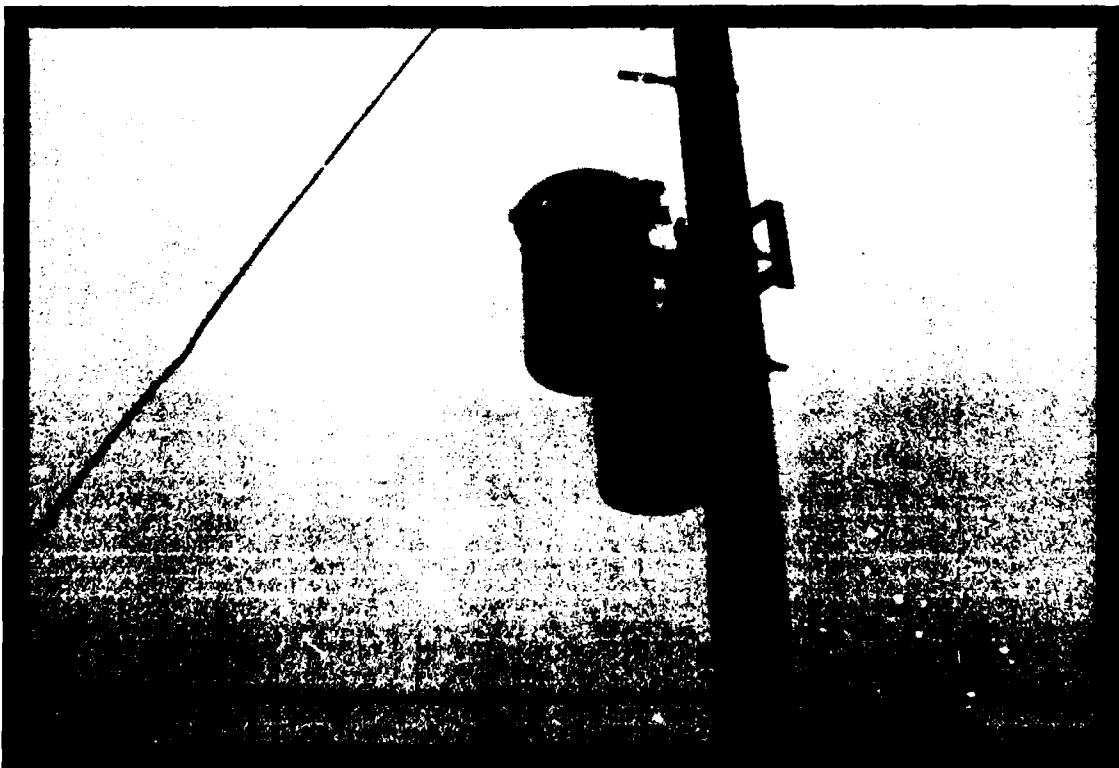
**5. TRANSFORMERS**

There are two pole-mounted transformers at the site. Both units have been severely damaged and are marked with numerous bullet holes. Presumably, most of the dielectric fluid has escaped (see photo 5). Given the age of the facility, it is possible that both may have contained polychlorinated biphenyls (PCBs).

It is expected that the fluid that leaked from the damaged transformers has seeped into the ground. No staining was visible. Some residual fluid may still be present on interior surfaces of the transformers.
